Lower Animas River Watershed Based Plan

Accepted by EPA August 9, 2016

Mountain Studies Institute
SAN JUAN MOUNTAINS, COLORADO

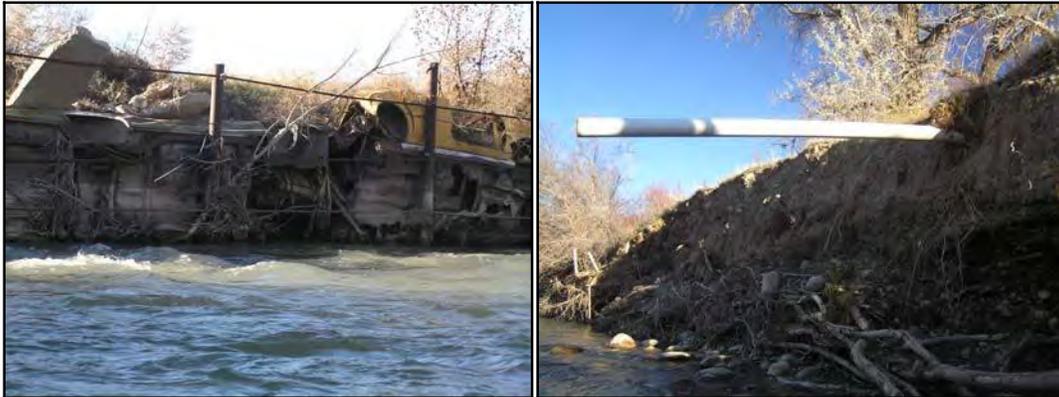
Figure 16. Picture of inappropriate bank stabilization (L) and actively eroding bank (R).

Results of this mapping showed that at least 8% of the 38.7 mile length of the study reach is in poor condition, with over 1 mile of actively incising channel and over 2 miles of rip-rapped bank with materials such as boulders, automobiles, scrap concrete, gabions, scrap metal, and other refuse (BUGS 2008).

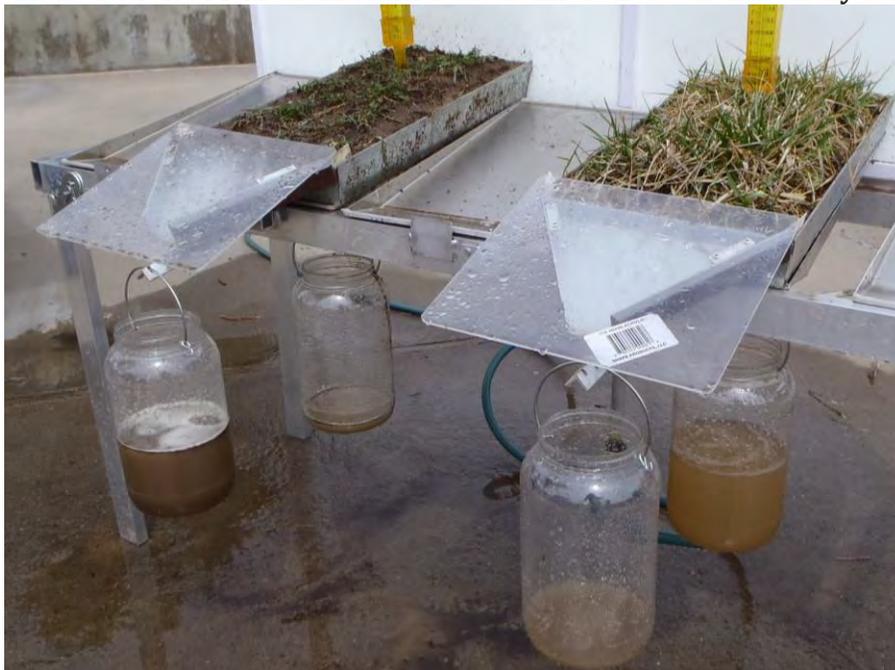
Figure 17. Demonstration of runoff and infiltration differences on unhealthy vs. healthy soils

The following image is from a 2015 Soil Health Workshop held in the Animas watershed. The soil on the left is characteristic of many areas within the Lower Animas. It is compacted, overgrazed, and has a high percentage of bare soil. The buckets below each soil show how much water ended up as runoff (front bucket) versus infiltration (back bucket) after a simulated one-inch rainfall. The increased infiltration rates associated with healthy soils lead to the attenuation of flood peaks, and increased flows to the river via groundwater during dry conditions. Promoting management for soil health will move more land in the watershed from the condition of the left soil to the one on the right.

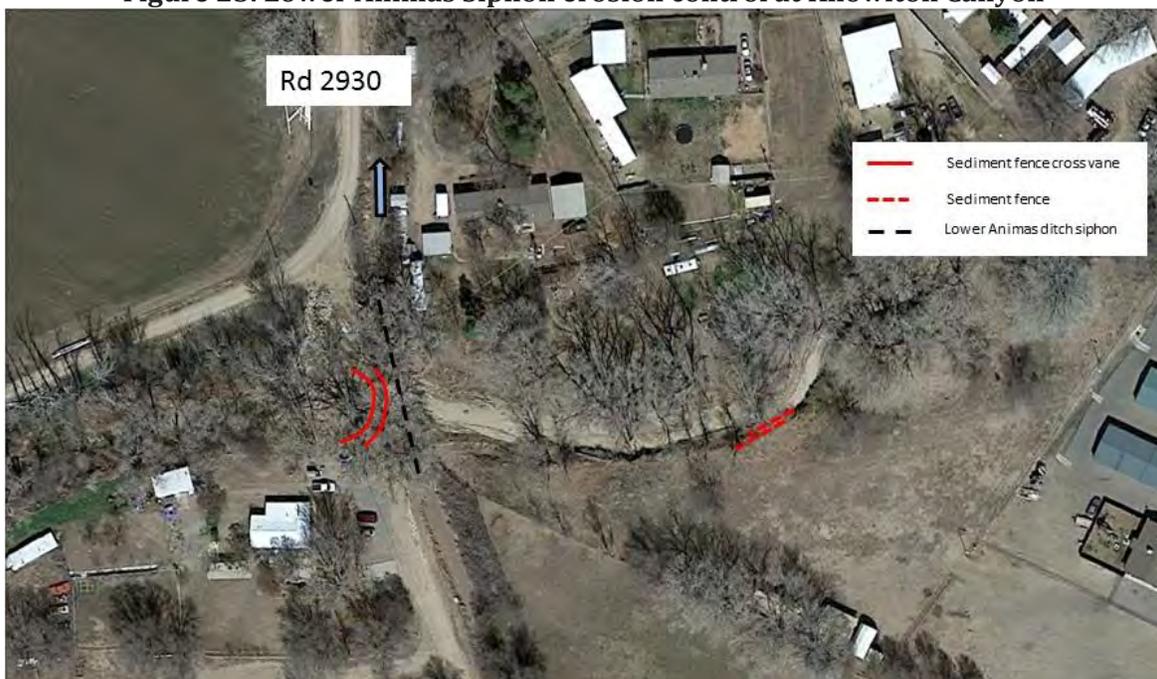
FV5. The Lower Animas irrigation ditch is siphoned under the ephemeral, sand bed Hart Valley Arroyo approximately 700 ft. downstream of CR3100. The Lower Animas Ditch Company is concerned about continual channel bed scour that exposes and jeopardizes the siphon structure and the conveyance of ditch water west beyond this arroyo. Ongoing headcutting within the arroyo system is lowering the channel bed in this reach which is also exacerbated by a large headcut on the downstream side of CR3100 and the ditch company excavating the arroyo between the siphon and CR3100 to generate fill material for use over the siphon.

Figure 24. Lower Animas Siphon erosion control at Hart Valley

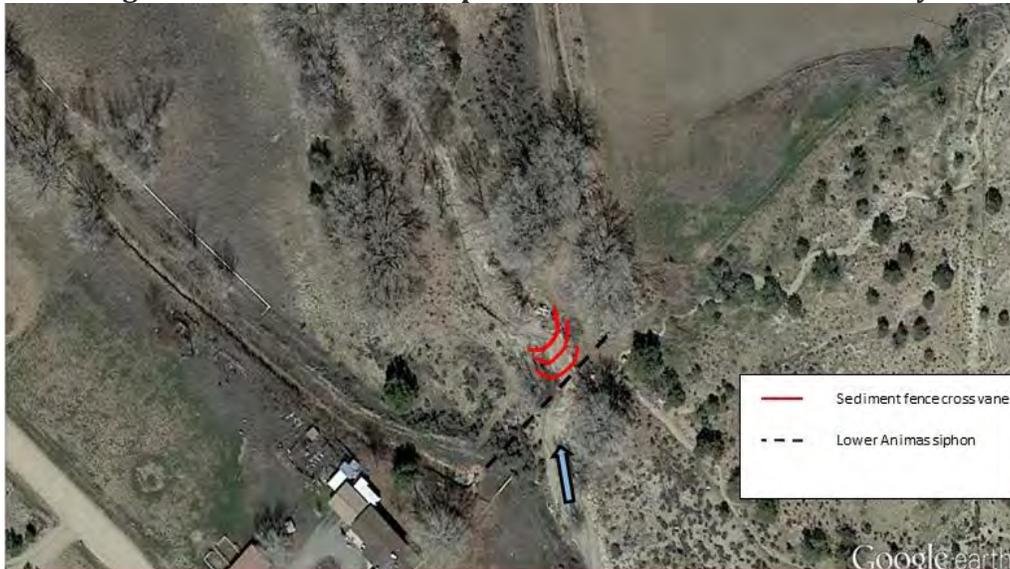
Figure 24 shows the areas and types of treatments identified with this reach. A brief survey will be required prior to construction to determine the appropriate "flowline" elevations and widths and how the banks will need to be regraded to provide a smooth transition through the reach. Benefits of this project include significant reductions in sediment displaced by a continually downcutting channel and related regrading efforts following flood events that scour the project area.

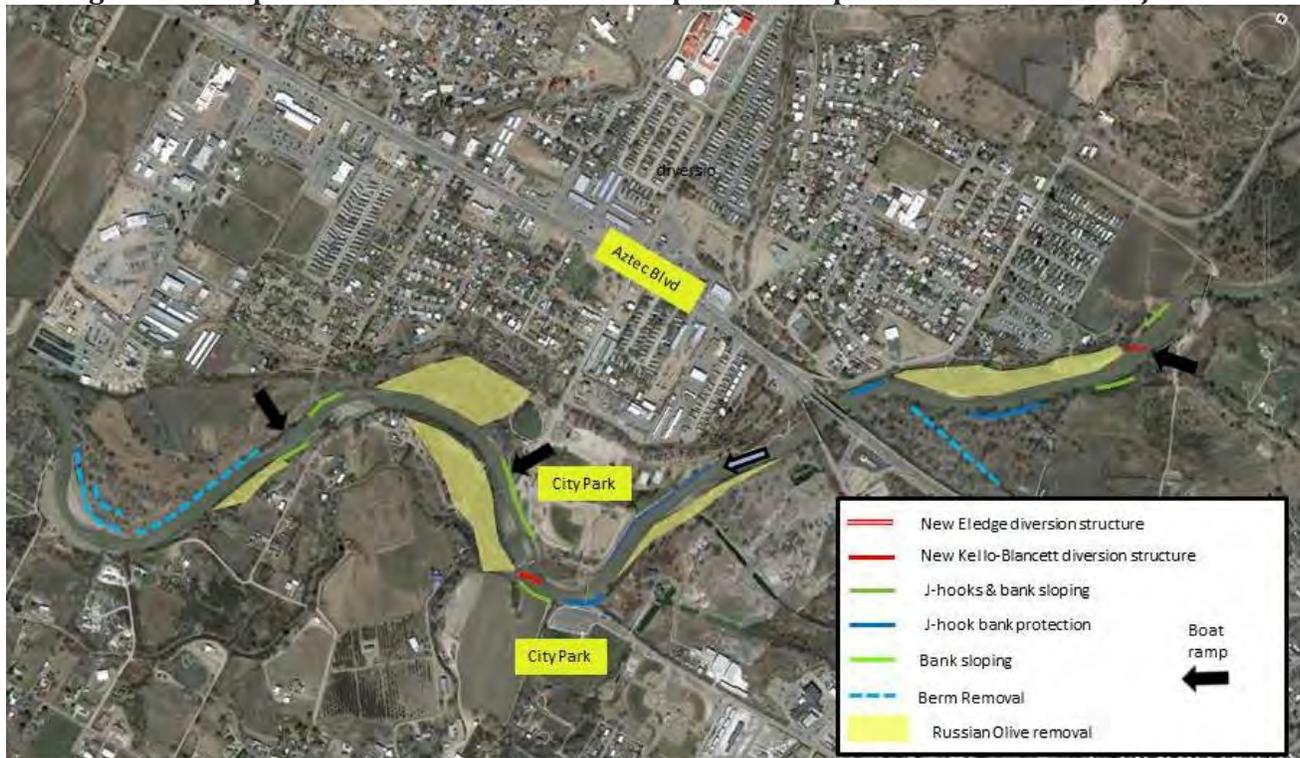
Figure 25. Proposed BMPs for the Aztec Floodplain and Riparian Restoration Project
